Phase One Environmental Site Assessment

Framgard Property, Regional Road 25 and Britannia Road
Milton, Ontario

January 19, 2024

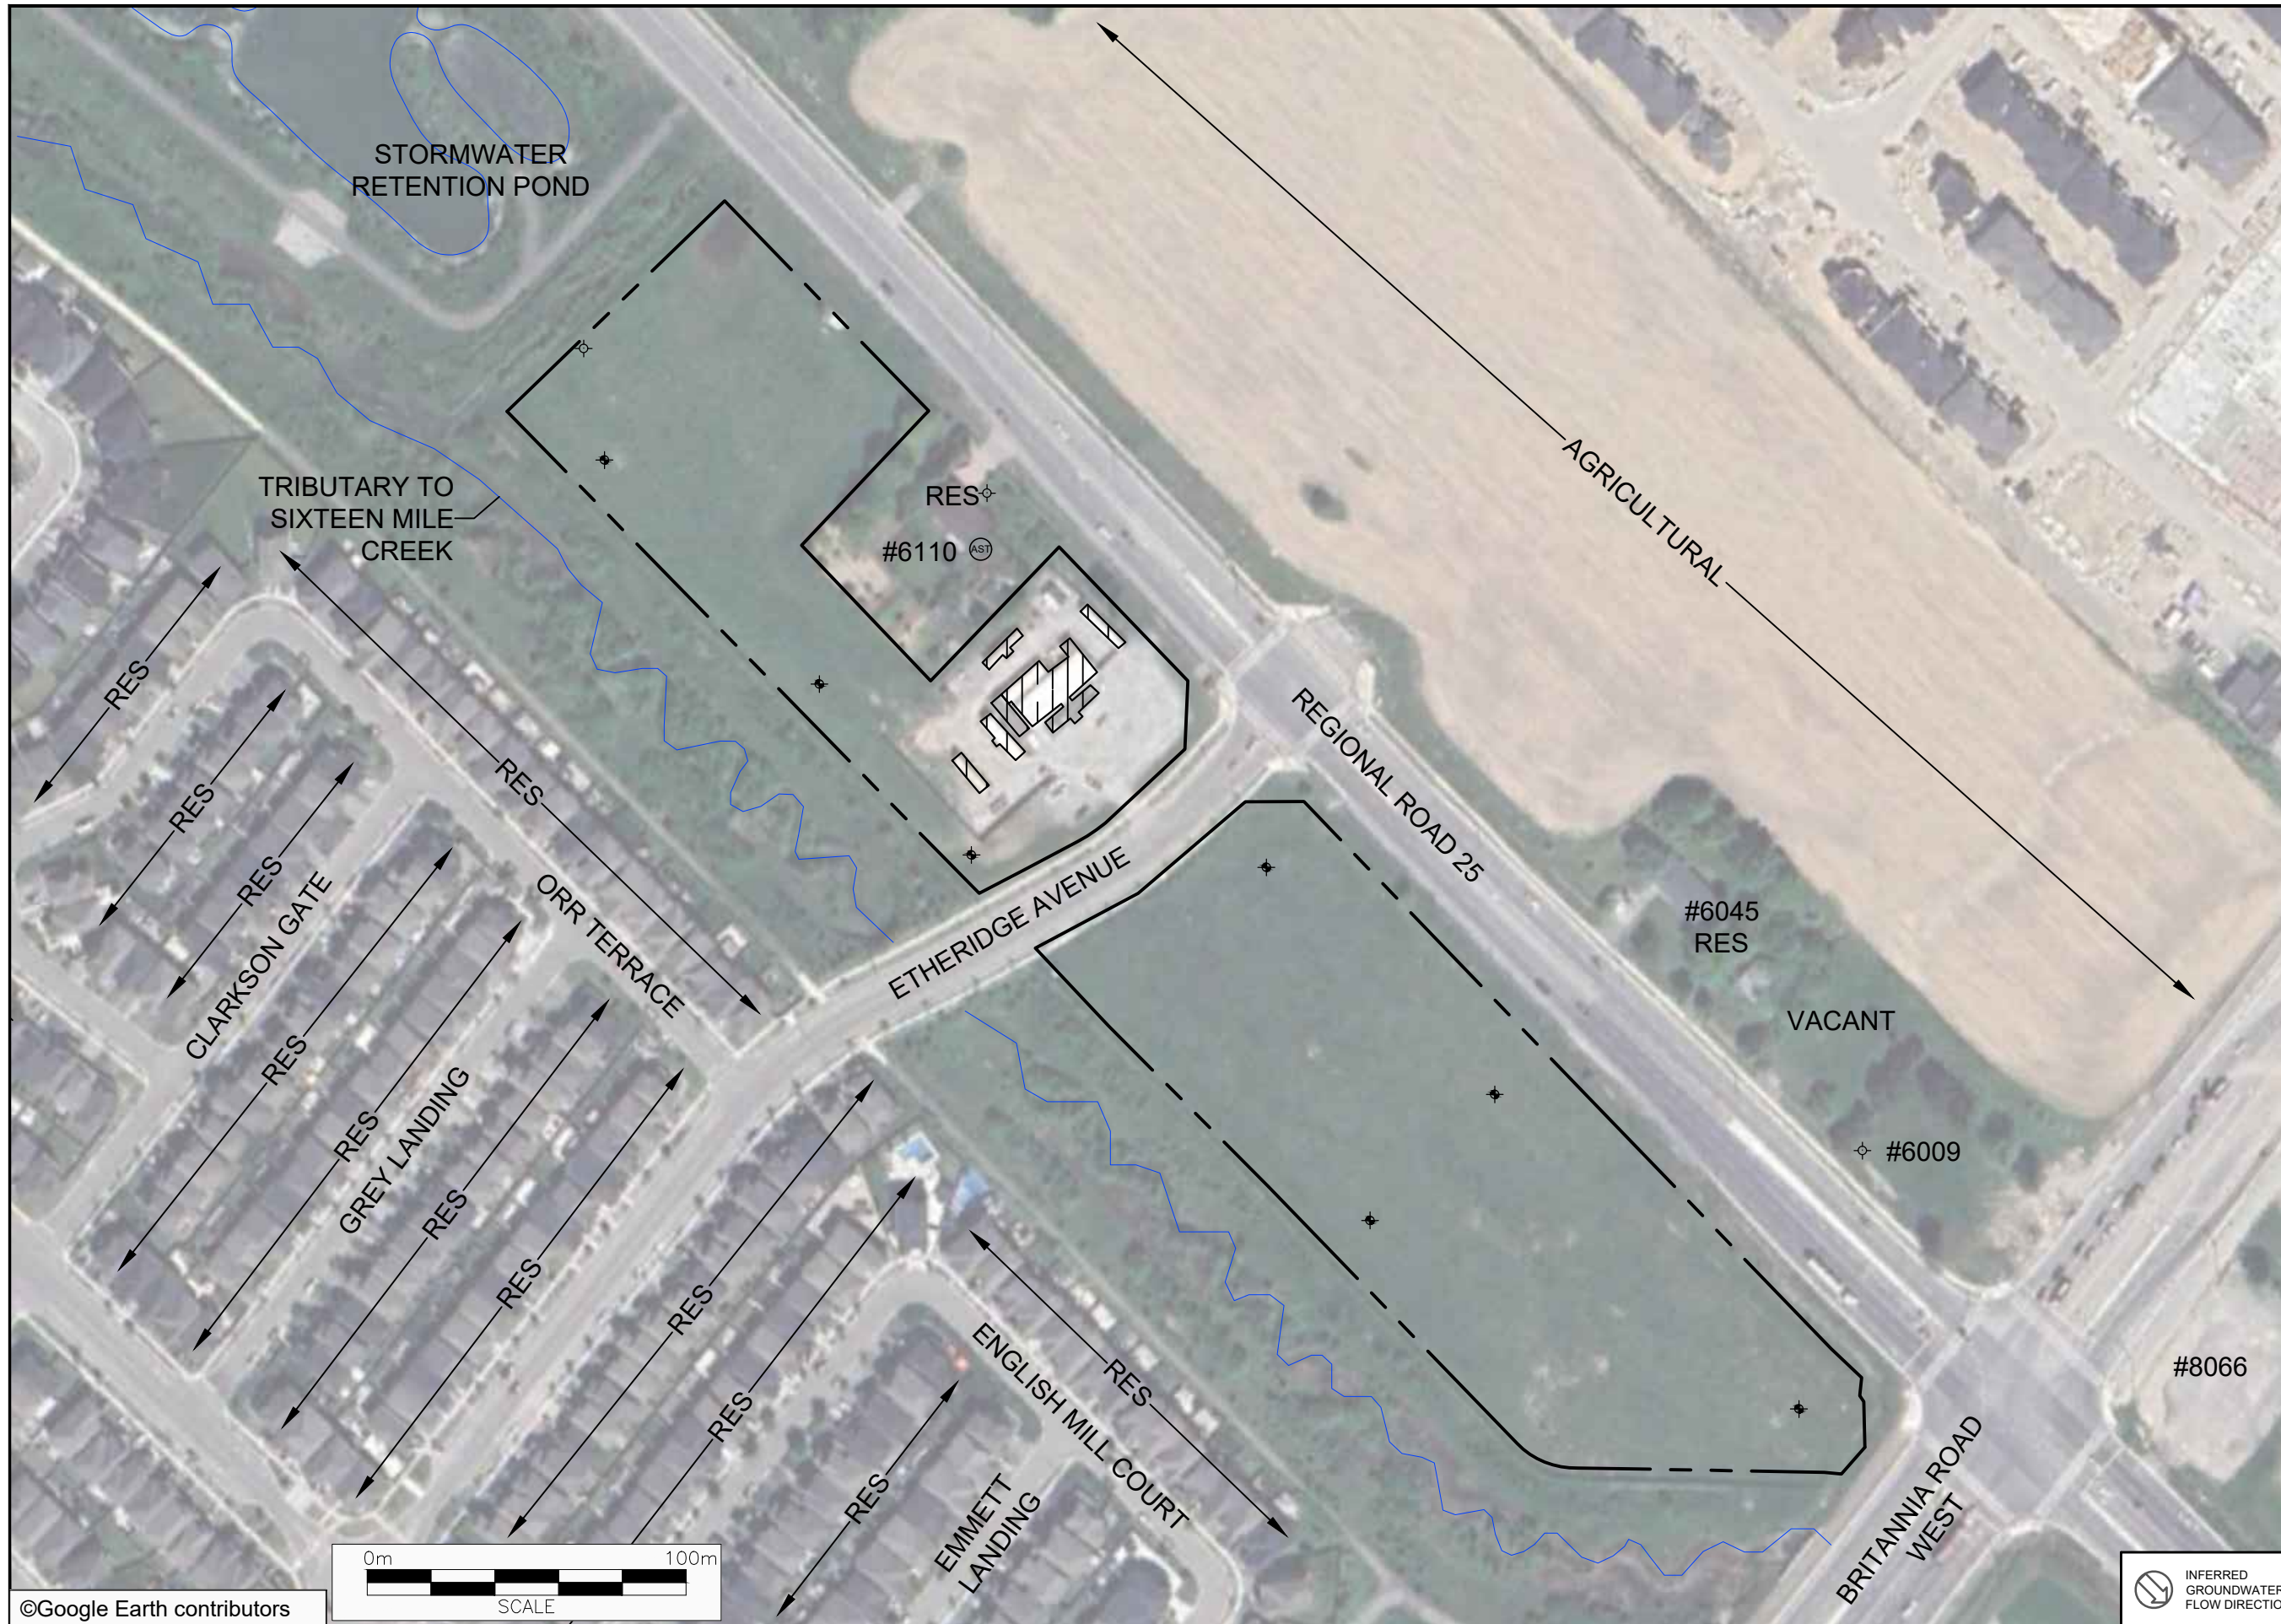
PROJECT NUMBER: 321286.001	SCALE: AS SHOWN
DRAWN BY: KP	REVIEWED BY: BP
DATE: JANUARY 2024	FIGURE NUMBER: 2

- PHASE ONE PROPERTY BOUNDARY
- ▨ SITE BUILDING
- RES RESIDENTIAL
- ⊕ MONITORING WELL LOCATION
- ⊙ DOMESTIC WATER WELL LOCATION
- WATERCOURSE
- ⊕ (AST) ABOVEGROUND STORAGE TANK

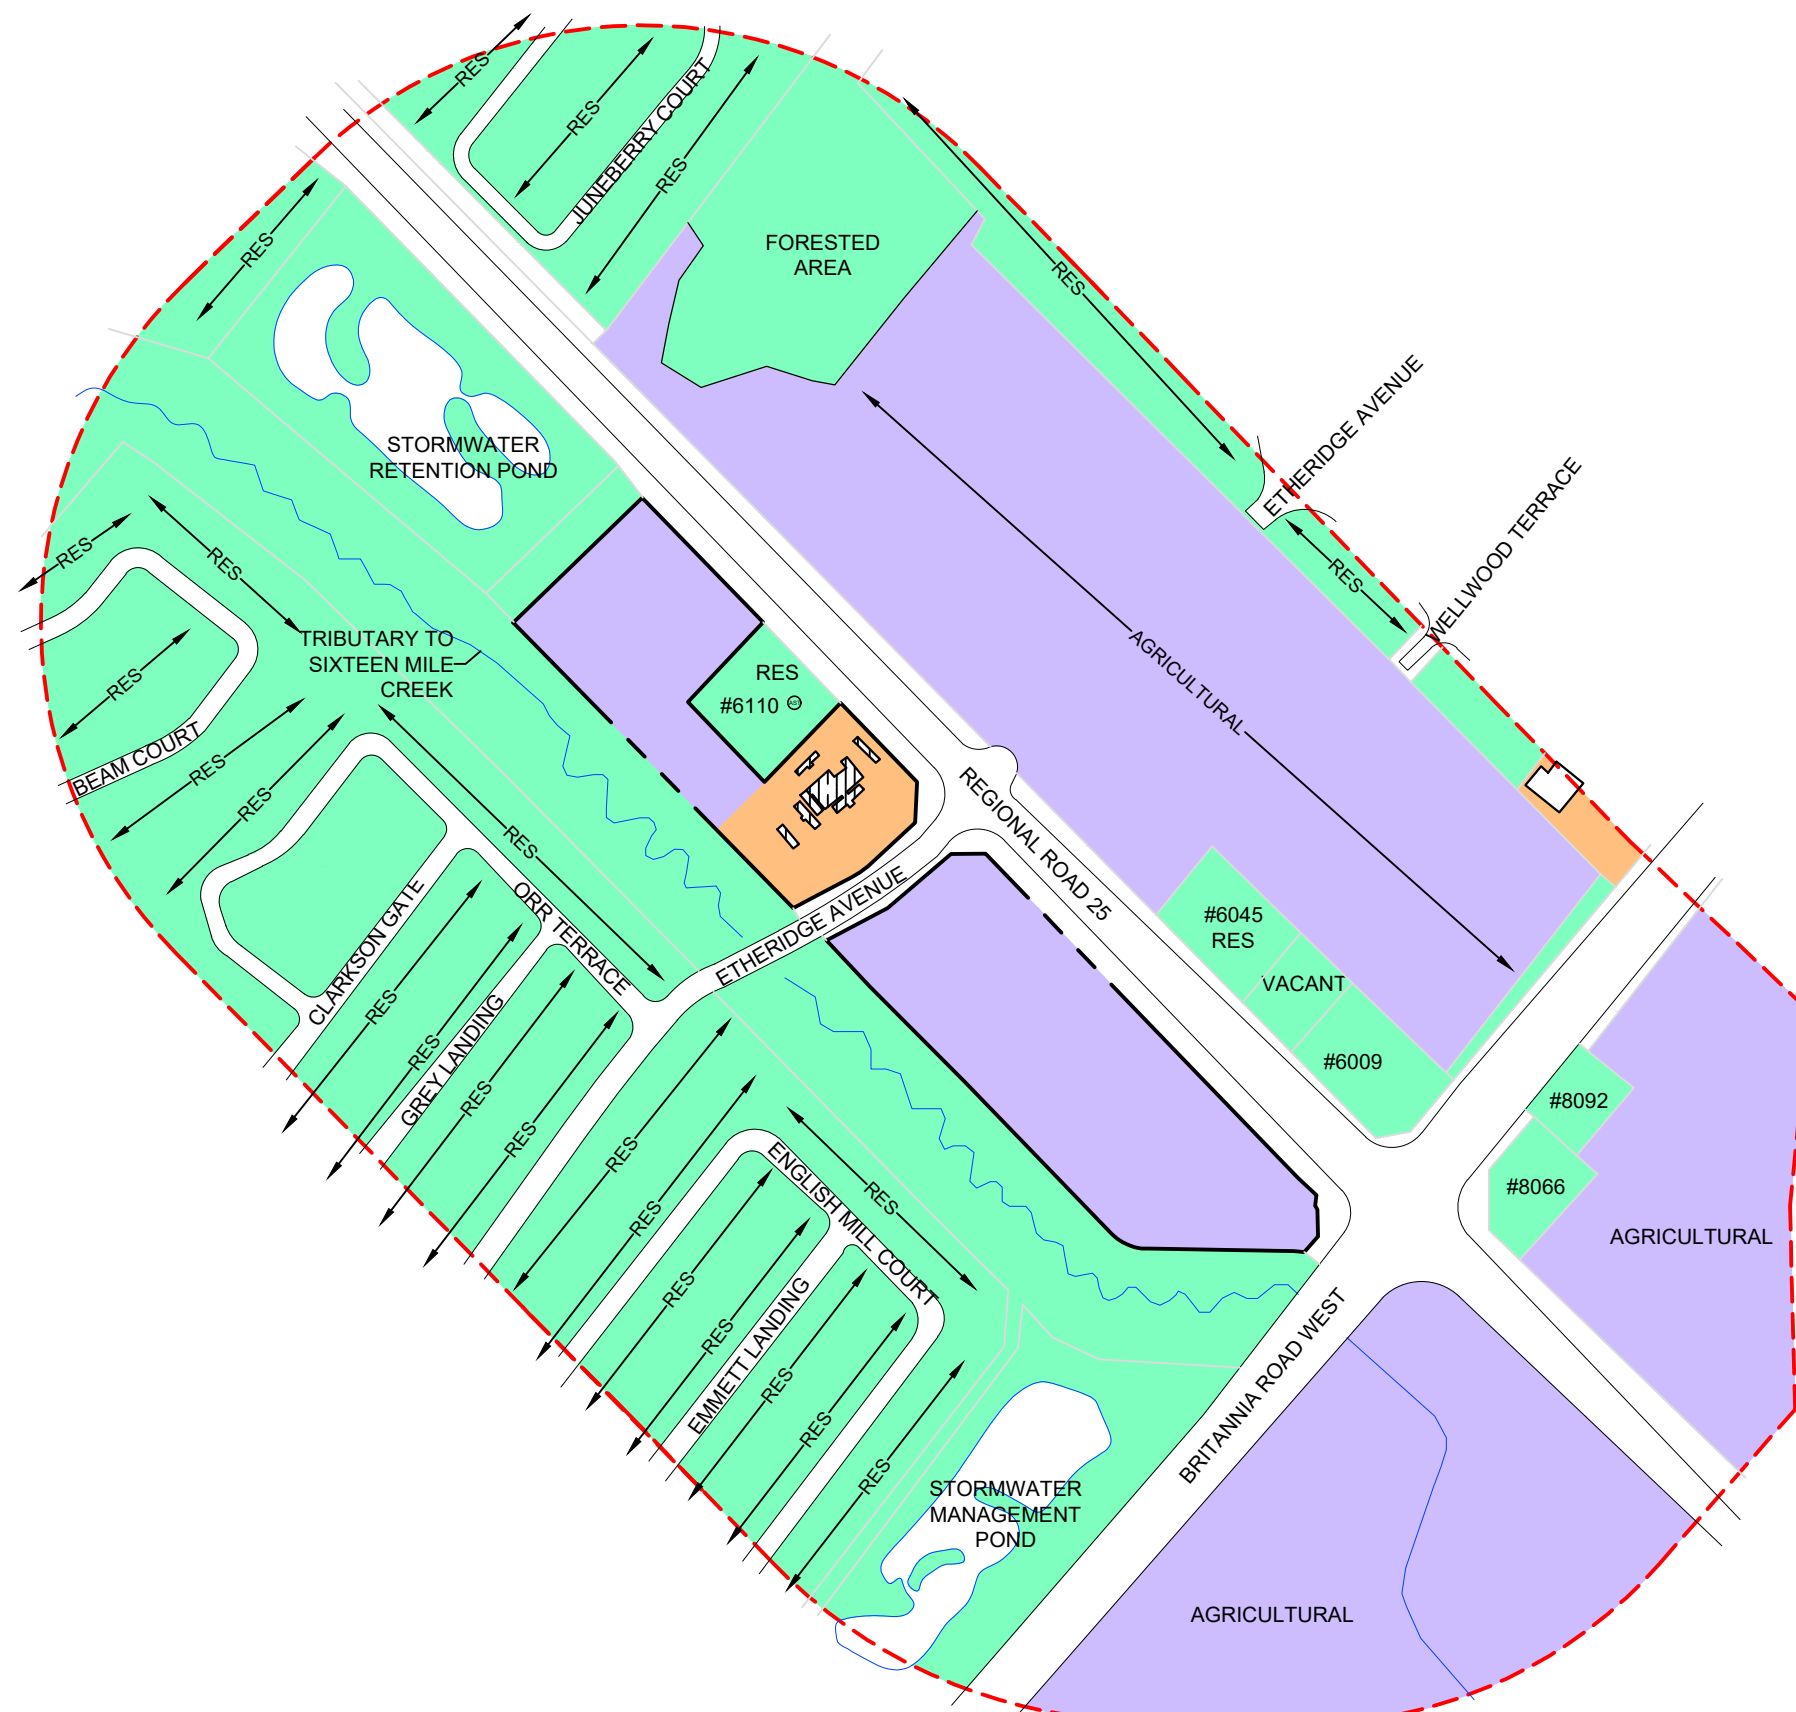
DATE: JANUARY 2024	FIGURE NUMBER: 3
-----------------------	---------------------

- LEGEND**
- PHASE ONE PROPERTY BOUNDARY
 - - - PHASE ONE STUDY AREA BOUNDARY
 - SITE BUILDING
 - RES RESIDENTIAL
 - WATERCOURSE
 - INDUSTRIAL/COMMERCIAL/COMMUNITY LAND USE
 - RESIDENTIAL/PARKLAND/INSTITUTIONAL LAND USE
 - AGRICULTURAL OR OTHER LAND USE
 - ABOVEGROUND STORAGE TANK

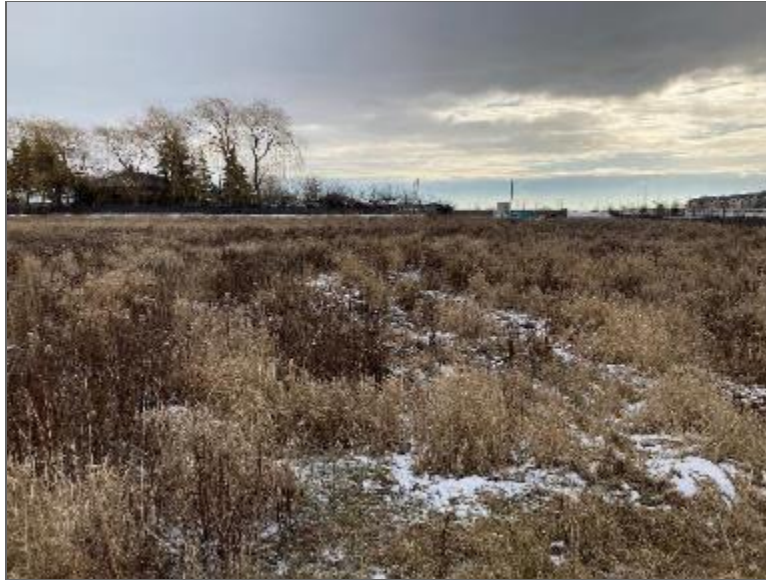
Photo 1 – View of the North Block of the Phase One Property (facing southeast).

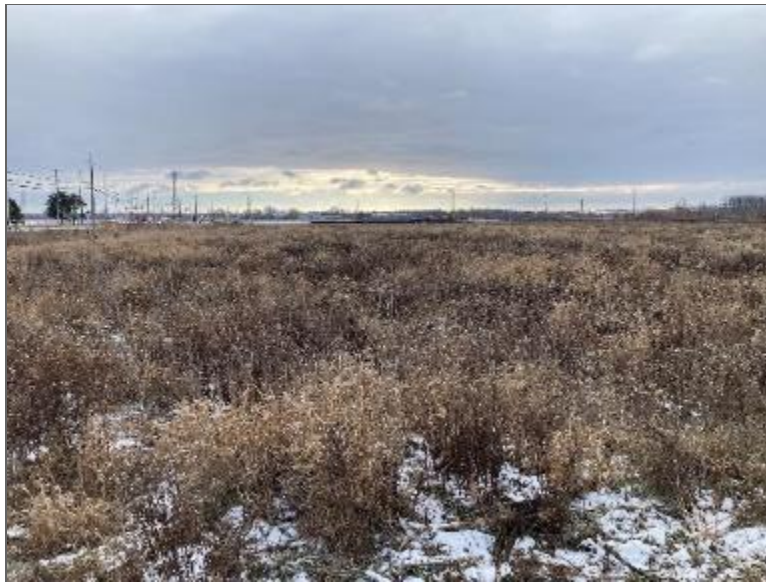
Photo 2 – View of the South Block of the Phase One Property (facing southeast).

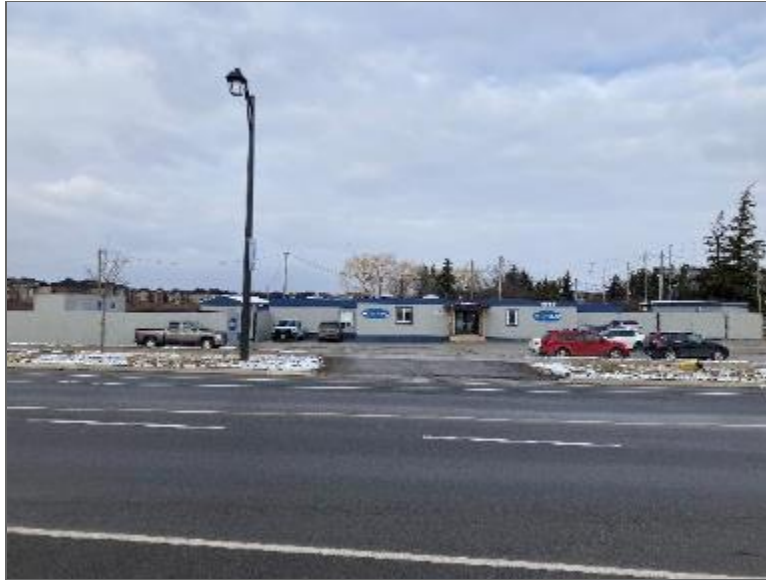
Photo 3 – View of the temporary sales centre on the south portion of the North Block of the Phase One Property (facing northwest).

During the Site reconnaissance, Pinchin observed one temporary building/structure composed of multiple construction trailers as well as storage sea containers on the Phase One Property. The temporary building structure consisted of various single-storey wood modular construction trailer units connected by hallways and decking and was constructed in approximately 2013. The modular construction trailers were divided into office spaces, lunchroom, washrooms and storage spaces.
